## TEST REPORT FOR SOUNDPROOFING OF SECURITY DOOR

Client: Alexiou Doors

Report. No: 250307-21

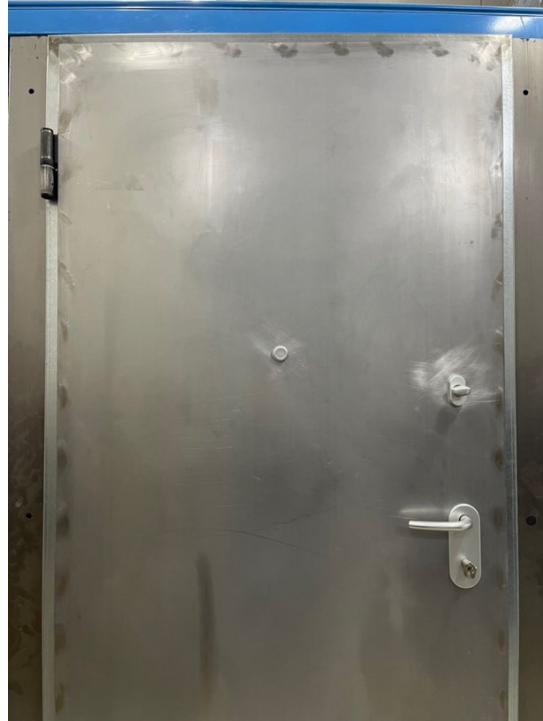
Figure 1: Door in the as delivered state before the start of the test, sectioning the two rooms.

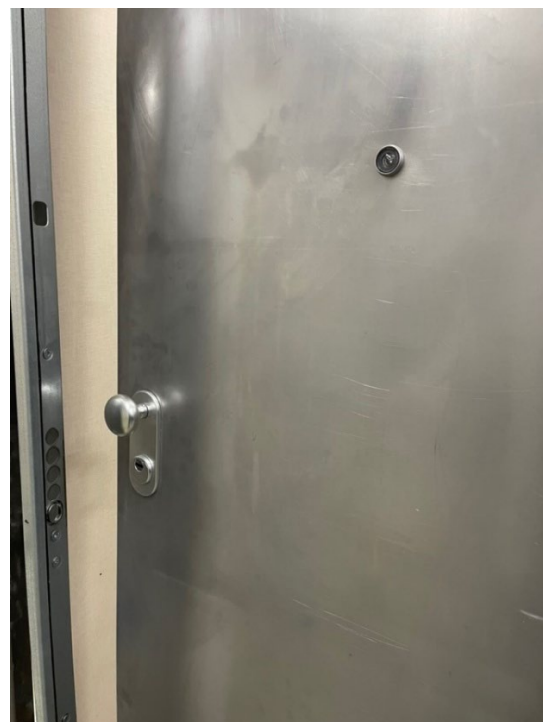
Figure 2: Door in the as delivered state before the start of the test, sectioning the two rooms.

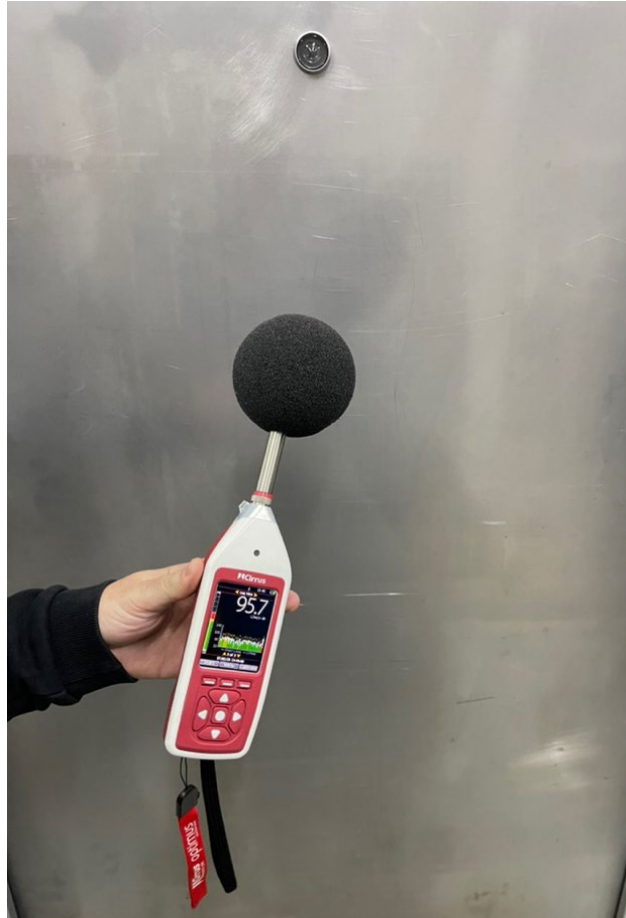
Figure 3: Measurement taken inside the sound proofing room during the test.

After completing the test procedures, the security door's sound insulation performance was evaluated, and the results were analyzed to assess its effectiveness in soundproofing. The measurements taken in the source room were 88 dB and 124 dB, while the corresponding measurements in the receiving room were 61 dB and 95 dB, respectively. This indicates that the security door provided a sound reduction of 27 dB at lower frequencies and 29 dB at higher frequencies. These results suggest that the door effectively reduces airborne noise, making it suitable for applications where sound insulation is critical. The observed sound reduction values demonstrate that the door meets the expected performance criteria for noise control, contributing to a quieter and more secure environment.
