## Fire resistance test for a door assembly (door-set) - Test report

“ΑΦΟΙ ΑΛΕΞΙΟΥ ΟΕ - PORTE ARMEE”

November 2018

PORTE\_ARMEE\_#1

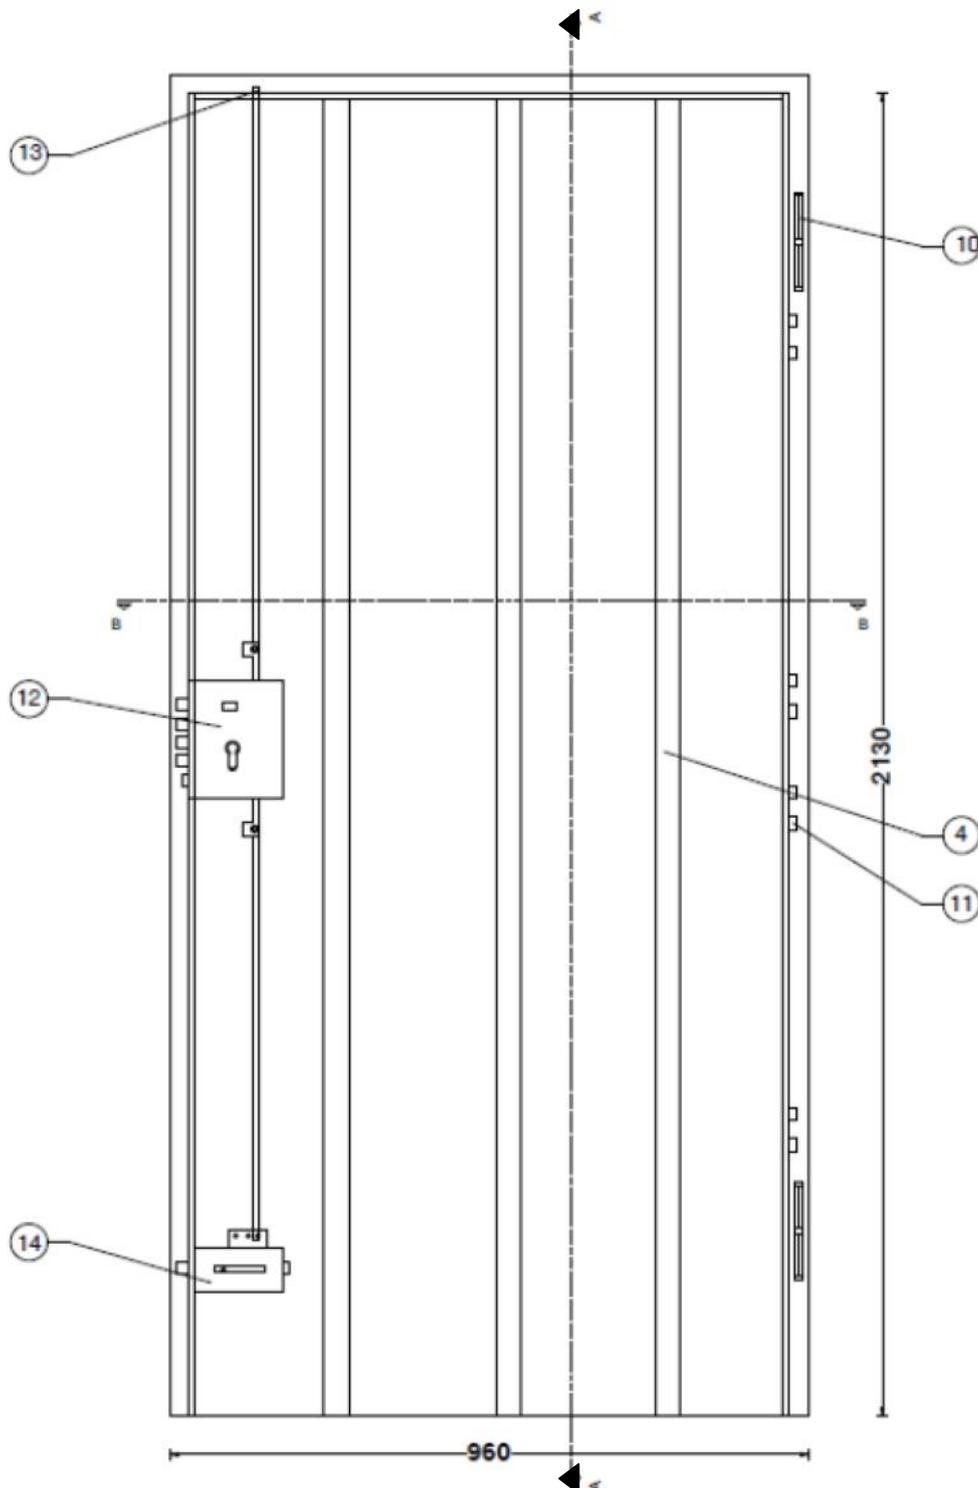
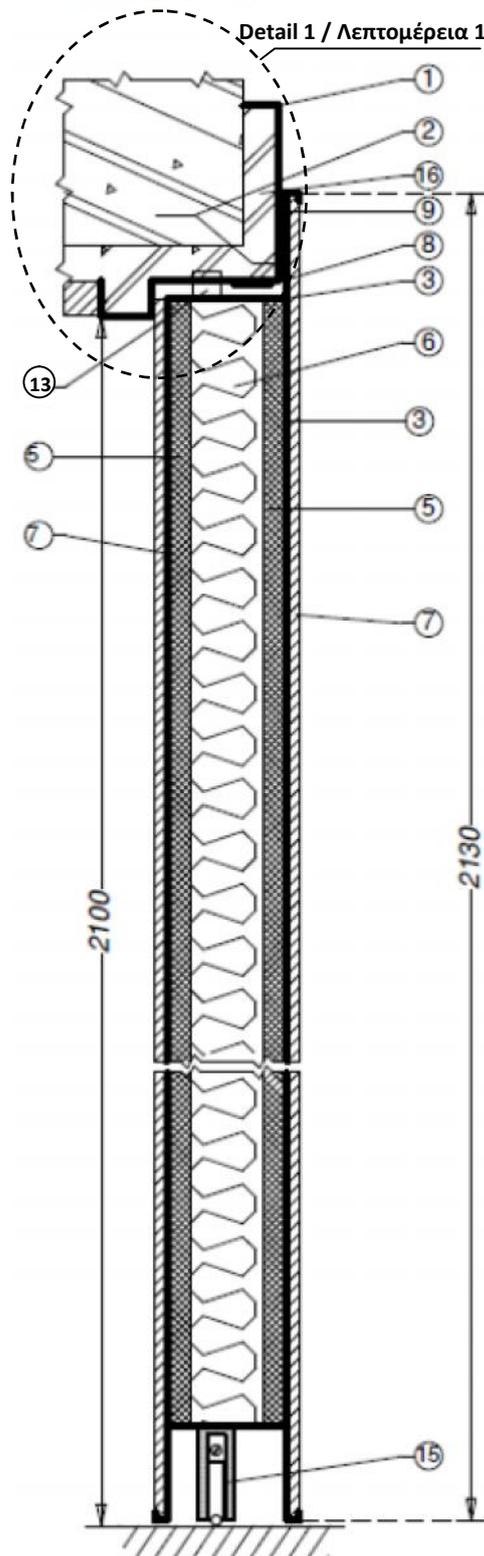
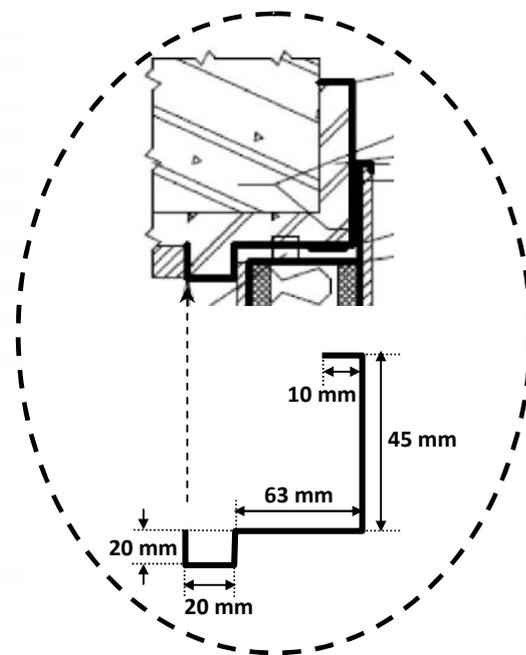
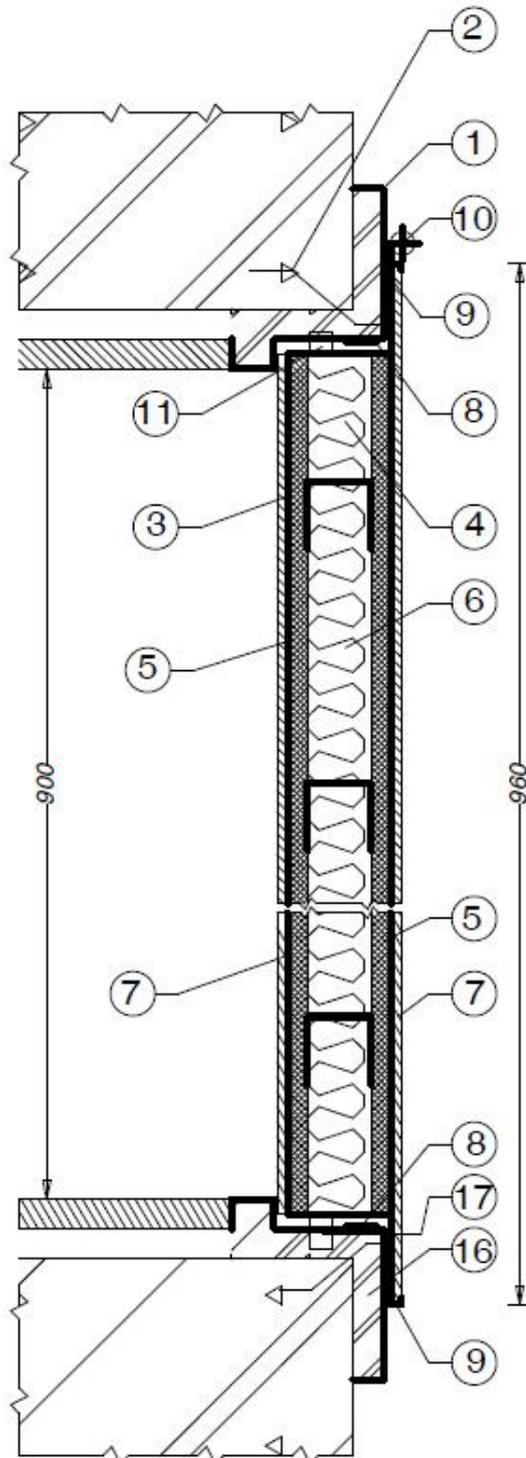
Fig. 1 Constructional details of the specimen

The test specimen comprised a single-action door-set installed in a rigid standard supporting construction (as per EN 1363-1). The door-set was designated by the assignor as “Πόρτα ασφαλείας – Πυρασφαλείας” (Fire-resistant safety door-set). The test specimen and all its components were full size (as used in service). The door-set was hinged with timber leaves and a metal frame (no transom). The total thickness of the door was equal to 70 mm. Constructional details are depicted in **Fig. 1**.

- 4. Π-shaped steel stiffeners 1.25 mm thick / Χαλύβδινες νευρώσεις σε σχήμα Π πάχους 1,25 mm
- 10. Adjustable heavy-duty hinge / Μεντεσές περιστρεφόμενος βαρέως τύπου ρυθμιζόμενος
- 11. Immovable pins / Σταθεροί πείροι
- 12. Safety cylinder lock / Κλειδαριά ασφαλείας κυλίνδρου
- 13. Top latch / Πάνω σύρτης
- 14. Bottom deflector / Κάτω εκτροπέας

1. Steel frame 2 mm thick / Χαλύβδινο πλαίσιο (κάσα) πάχους 2 mm
2. Z-shaped steel brackets 2 mm thick / Τζινέτια σε σχήμα Z πάχους 2 mm
3. Steel door leaf 1 mm thick / Χαλύβδινο φύλλο πόρτας πάχους 1 mm

5. Fire-resistant plasterboard 12 mm thick (KNAUF) / Πυράντοχη γυψοσανίδα πάχους 12 mm (KNAUF)
6. Rockwool with a density of 80 kg/m<sup>3</sup>, 30 mm thick (FIBRANgeo) / Πετροβάμβακας πυκνότητας 80 kg/m<sup>3</sup>, πάχους 30 mm (FIBRANgeo)

7. Wooden paneling 7 mm thick/ Επένδυση ξύλινη πάχους 7 mm
8. Self-adhesive fire & smoke intumescent strip placed on the steel frame / Στη μεταλλική κάσα, αυτοκόλλητη θερμοδιογκούμενη ταινία – φραγμός καπνού

9. Rubber seal strip / Λάστιχο στεγανοποίησης
13. Top latch / Πάνω σύρτης
15. Adjustable windbreak / Ανεμοφράκτης ρυθμιζόμενος
16. Steel frame-to-wall connection through lime-based plaster for test purposes (through cement in practice) / Σύνδεση της κάσας με τον τοίχο με γύψο για τη δοκιμή (τσιμέντο στην πράξη)

4. Π-shaped steel stiffeners 1.25 mm thick / Χαλύβδινες νευρώσεις σε σχήμα Π πάχους 1,25 mm
5. Fire-resistant plasterboard 12 mm thick (KNAUF) / Πυράντοχη γυψοσανίδα πάχους 12 mm (KNAUF)

6. Rockwool with a density of 80 kg/m<sup>3</sup>, 30 mm thick (FIBRANgeo) / Πετροβάμβακας πυκνότητας 80 kg/m<sup>3</sup>, πάχους 30 mm (FIBRANgeo)
7. Wooden paneling 7 mm thick / Επένδυση ξύλινη πάχους 7 mm

8. Self-adhesive fire & smoke intumescent strip placed on the steel frame / Στη μεταλλική κάσα, αυτοκόλλητη θερμοδιογκούμενη ταινία – φραγμός καπνού
9. Rubber seal strip / Λάστιχο στεγανοποίησης

10. Adjustable heavy-duty hinge / Μεντεσές περιστρεφόμενος βαρέως τύπου ρυθμιζόμενος
11. Immovable pins / Σταθεροί πείροι
16. Steel frame-to-wall connection through lime-based plaster for test purposes (through cement in practice) / Σύνδεση της κάσας με τον τοίχο με γύψο για τη δοκιμή (τσιμέντο στην πράξη)

17. Sliding safety lock pins / Κινητοί πείροι κλειδαριάς ασφαλείας

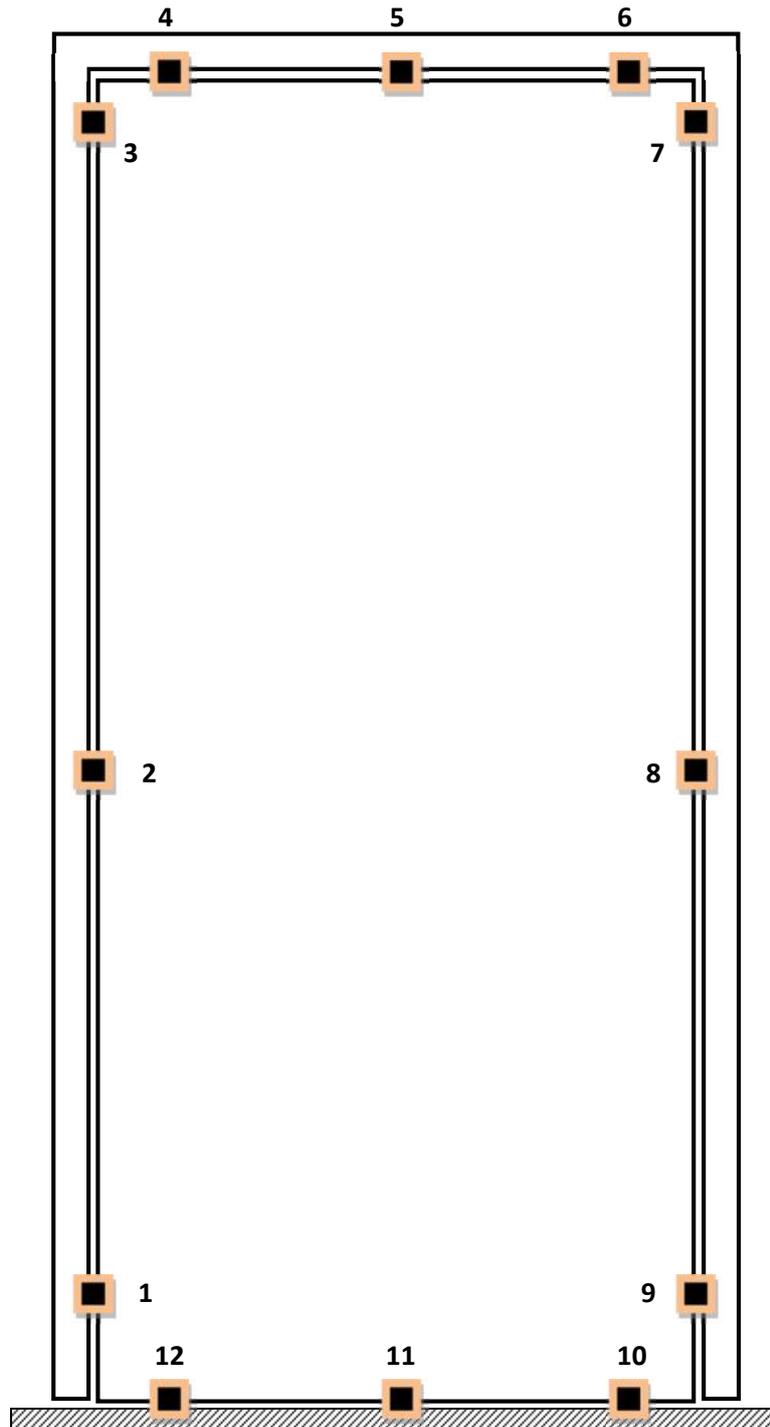
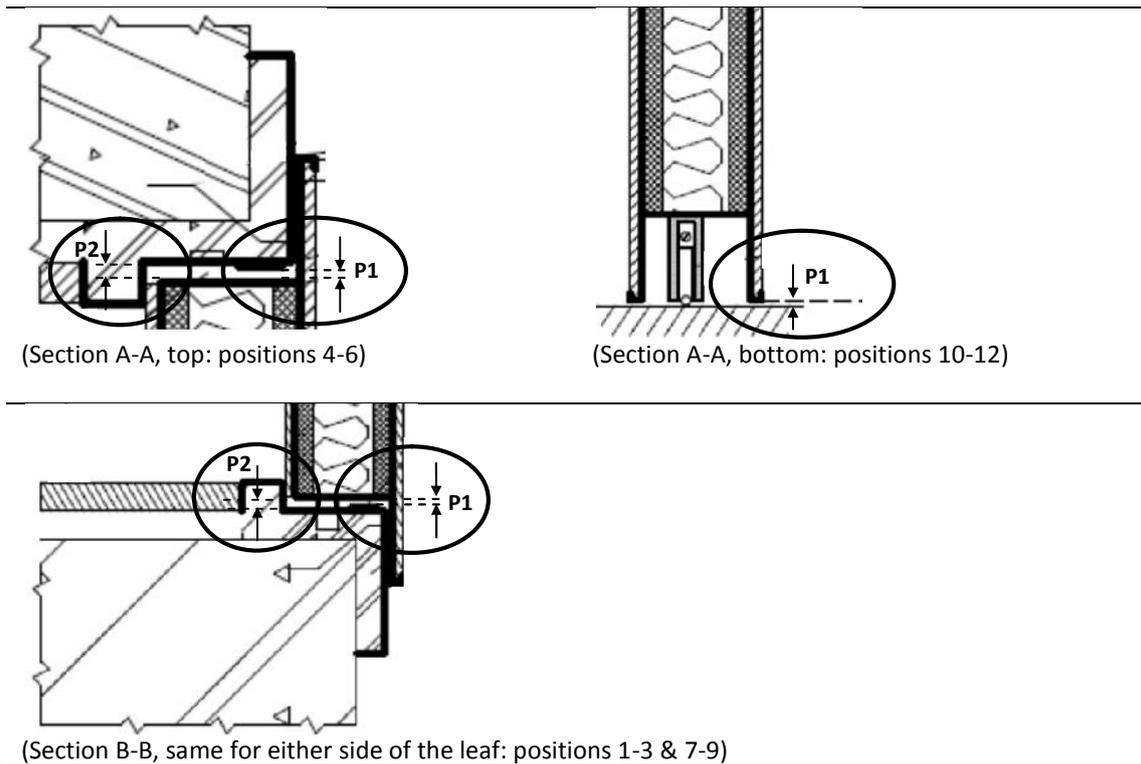
- b) Gap measurements: Gaps were either calculated or measured prior to the fire resistance test in accordance with the sequence given in EN 1634-1:2014. It is noted that gaps account for clearance between two nominally adjacent surfaces and/or edges. Primary gaps in particular are between the edge of the leaf and the reveal of the frame and between the face of the leaf and the frame stop. **Fig. 2** illustrates the positions at which gap measurements were taken. All gaps but those of positions 10-12 were internal; thus, they were calculated. Gaps at positions 10-12 were visible and were measured. All gap measurements are given in Table 1.

**Fig. 2. Positions at which gap measurements ( $P_i$ ) were taken.**

Gap measurements [mm, accuracy not exceeding 0.5 mm]	Positions											
	1	2	3	4	5	6	7	8	9	10	11	12
P1	2.5	2.5	2.5	3	3	3	2.5	2.5	2.5	5	5	5
P2	6.0	6.0	6.0	6.5	6.5	6.5	6.0	6.0	6.0	-	-	-

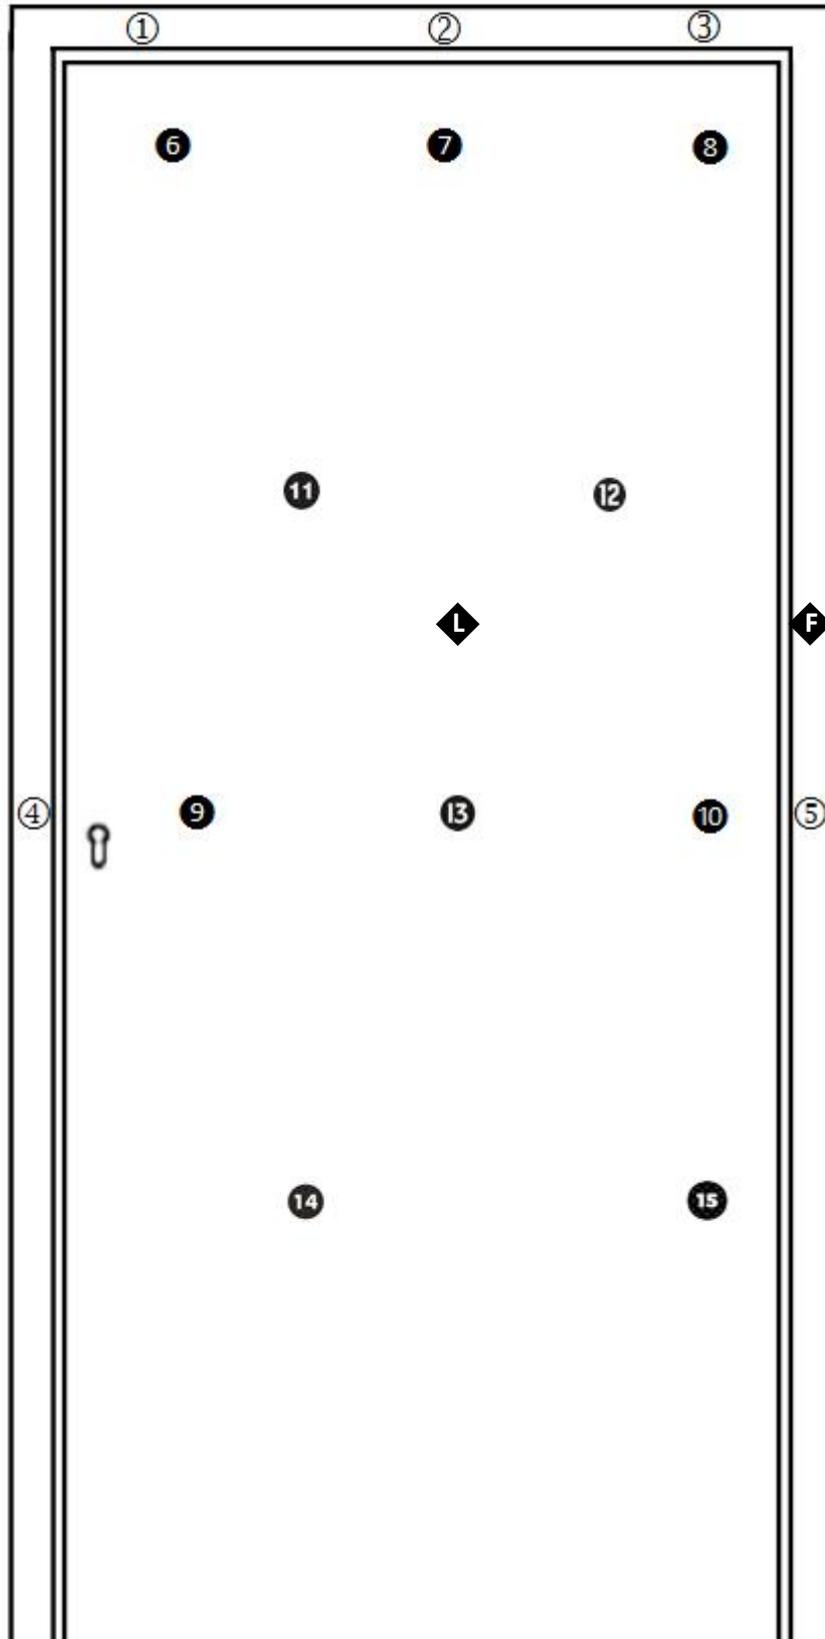
**Fig. 3** illustrates the layout of thermocouples on the unexposed surface of the test specimen. Thermocouples 1-5 were fixed on the steel frame of the door-set whereas thermocouples 6-15 were fixed on the door leaf. During the test the door leaf movement (deflection) relative to the frame was recorded at 1 min intervals. Both door leaf and frame deflections were measured by laser distance meters (range: 0.05 m to 100 m; measurement accuracy: 1.5 mm) placed on a fixed platform positioned 5 m away from the unexposed side of the specimen. Measurement points (laser targets) are shown in **Fig. 3** (“L” and “F” for leaf and frame measurement points, respectively). Zero leaf relative to door frame displacement was recorded.

Fig. 3. Layout of thermocouples on the unexposed surface of the test specimen

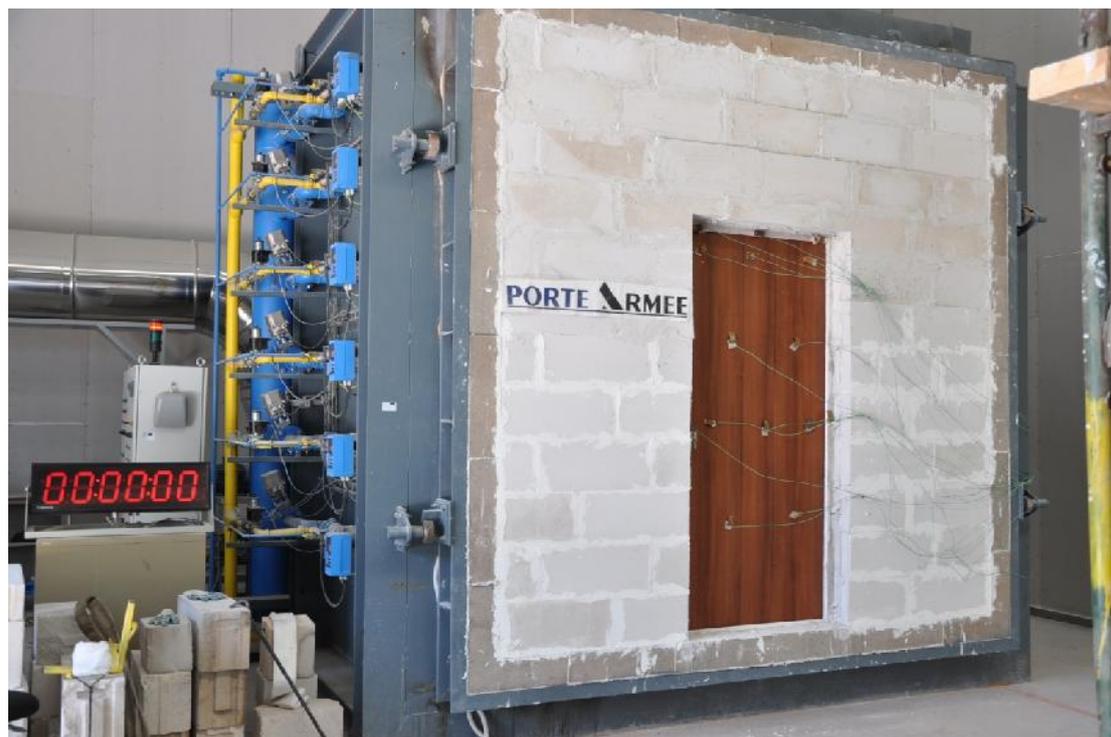
**Fig. 4. General layout of the specimen just prior to testing**

The general layout of the specimen just prior to testing is given in **Fig. 4**.

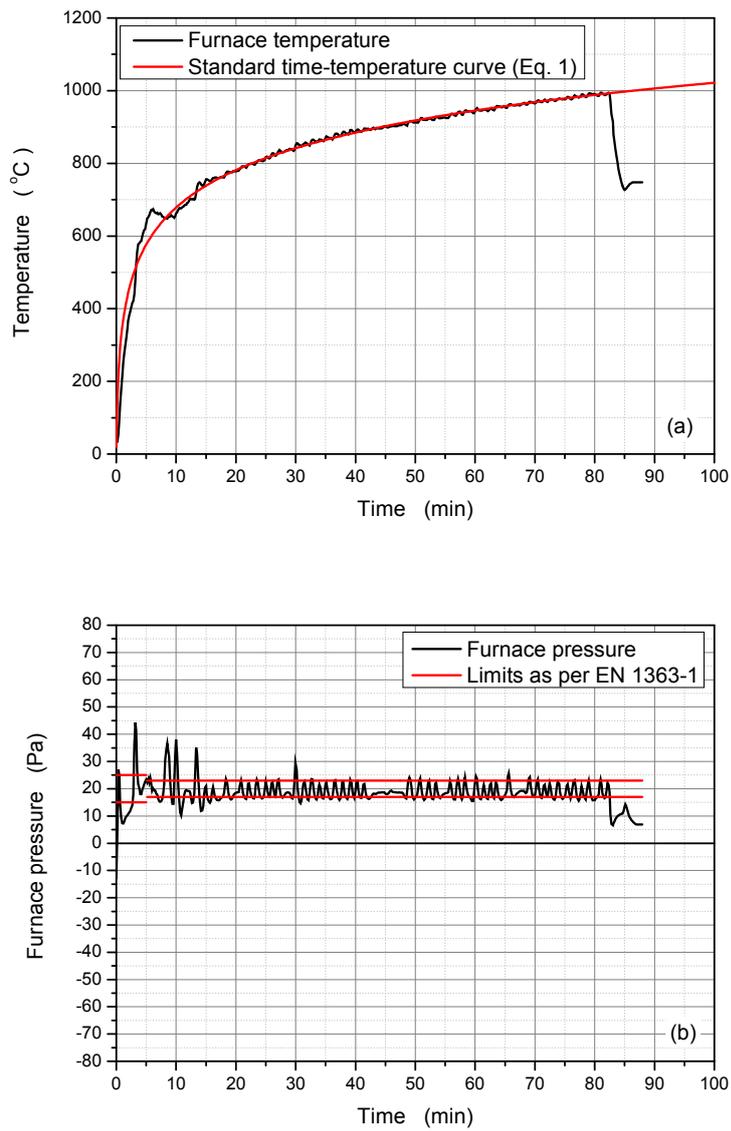
The time versus (actual) furnace temperature curve (in comparison to the standard – i.e. target – time versus temperature one) is given in **Fig. 5a**. The time versus furnace pressure is given in **Fig. 5b**. The percentage deviation ( $d_c$ ) in the area of the time versus actual furnace temperature curve from the area of the standard time/temperature curve is shown in **Fig. 6**; this deviation is compared in **Fig. 6** to the maximum permissible one referenced in EN 1363-1 (tolerance; red line in **Fig. 6**). For the total duration of the test (excluding the first 5 min)  $d_c$  was lower than the tolerance. The rapid temperature increase in the first 5 min of the test was responsible for the exceedance of the tolerance (common to fire resistance tests – see EN 1363-1).

**Fig. 5. (a) Time versus (actual) furnace temperature curve (in comparison to the standard – i.e. target – time versus temperature curve); (b) Time versus furnace pressure**

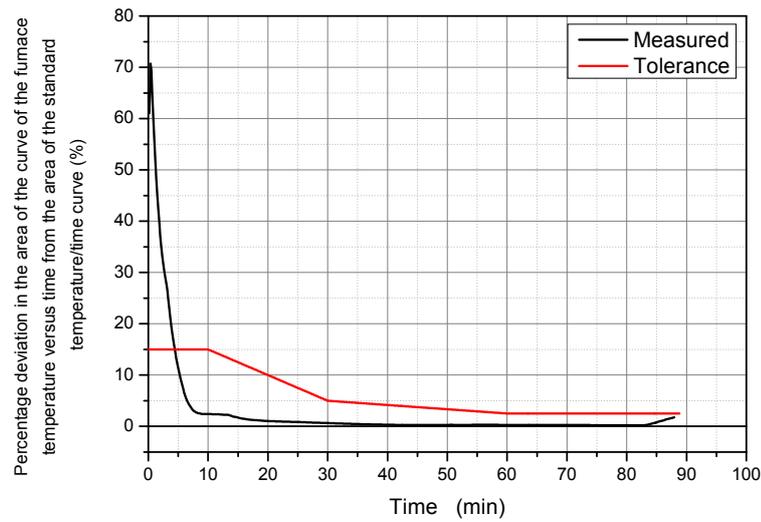
**Fig. 6 Percentage deviation in the area of the time versus actual furnace temperature curve from the area of the standard time/temperature curve and maximum permissible one as per EN 1363-1**

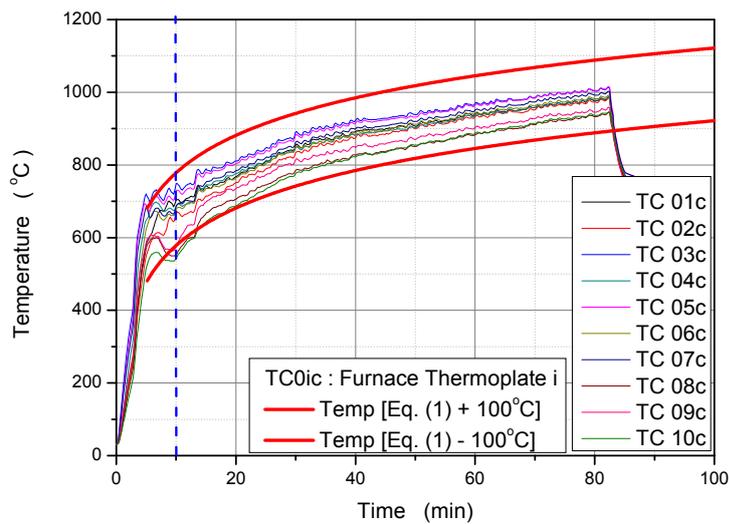
The temperature recorded by the furnace thermoplates (10 in number) versus time is shown in **Fig. 7**. At any time after the first 10 min of test, the temperature recorded by any thermoplate in the furnace

did not differ from the corresponding temperature of the standard temperature/time curve by more than 100°C (as required by EN 1363-1).

**Fig. 7 Time records of temperature recorded by each thermoplate in the furnace in comparison to limit temperatures (standard temperature  $\pm 100^{\circ}\text{C}$ )**

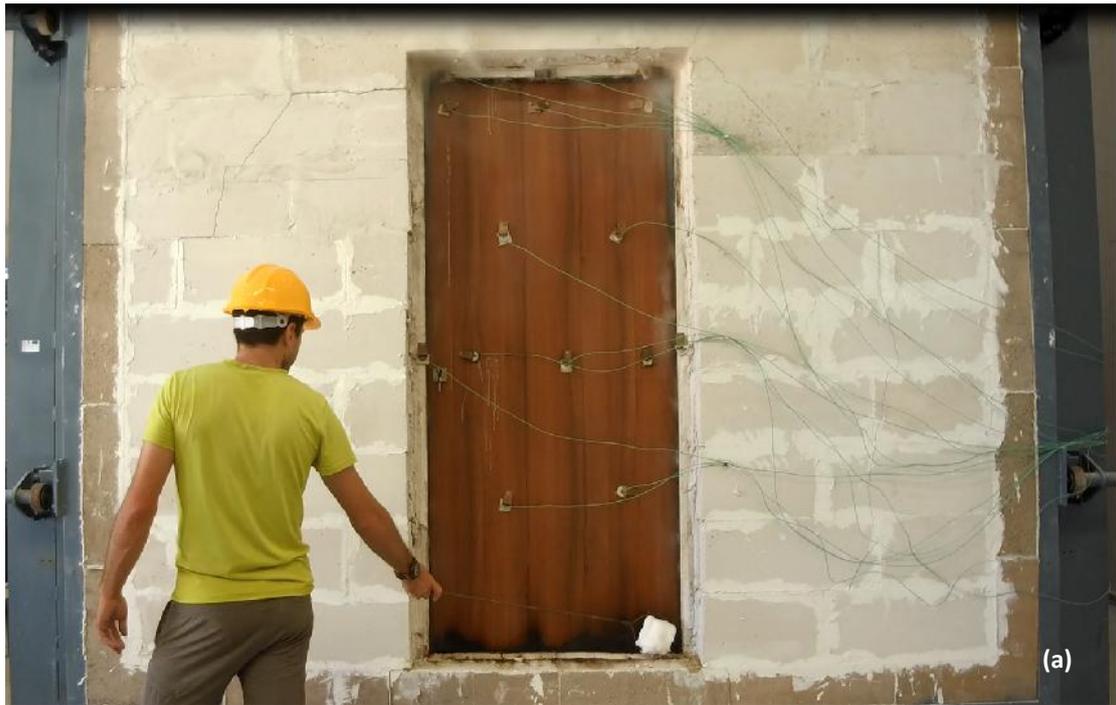
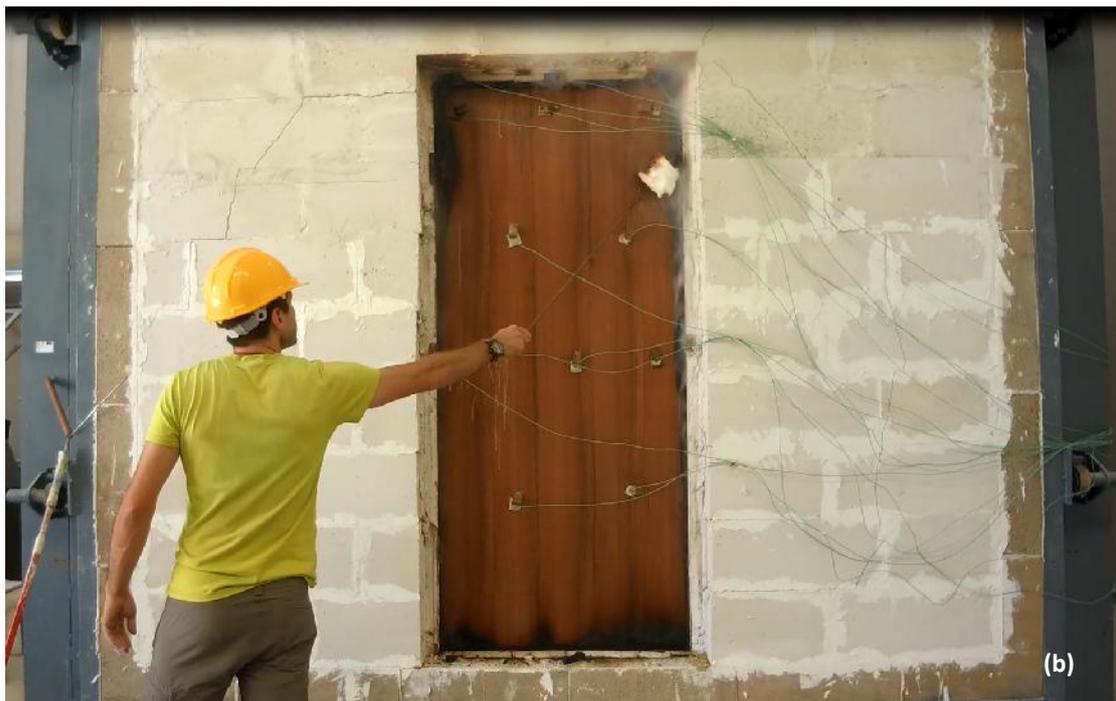
**Fig. 8 Cotton pad check: (a) 1h (cotton pad remained intact) and (b) 1h 19 min post the commencement of the test (cotton pad ignition)**

- (a) causing the ignition of a cotton pad applied in accordance to clause 10.4.5.2 of EN 1363-1 (**Fig. 8**);
- (b) permitting the penetration of a gap gauge as specified in clause 10.4.5.3 of EN 1363-1 (**Fig. 9**);
- (c) resulting in sustained flaming **Fig. 10**).

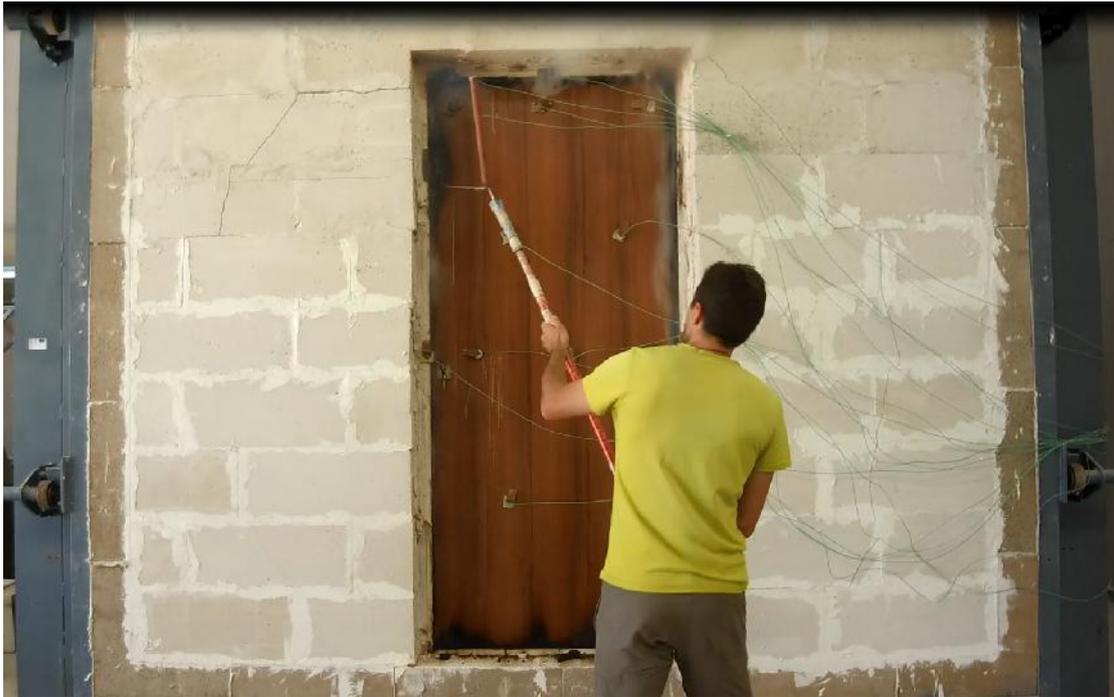
**Fig. 9 Gap gauge check: the 6 mm gap gauge can be passed through the test specimen such that the gauge projects into furnace (but cannot be moved a distance of 150 mm along the gap) at 1h 12 min post the commencement of the test**

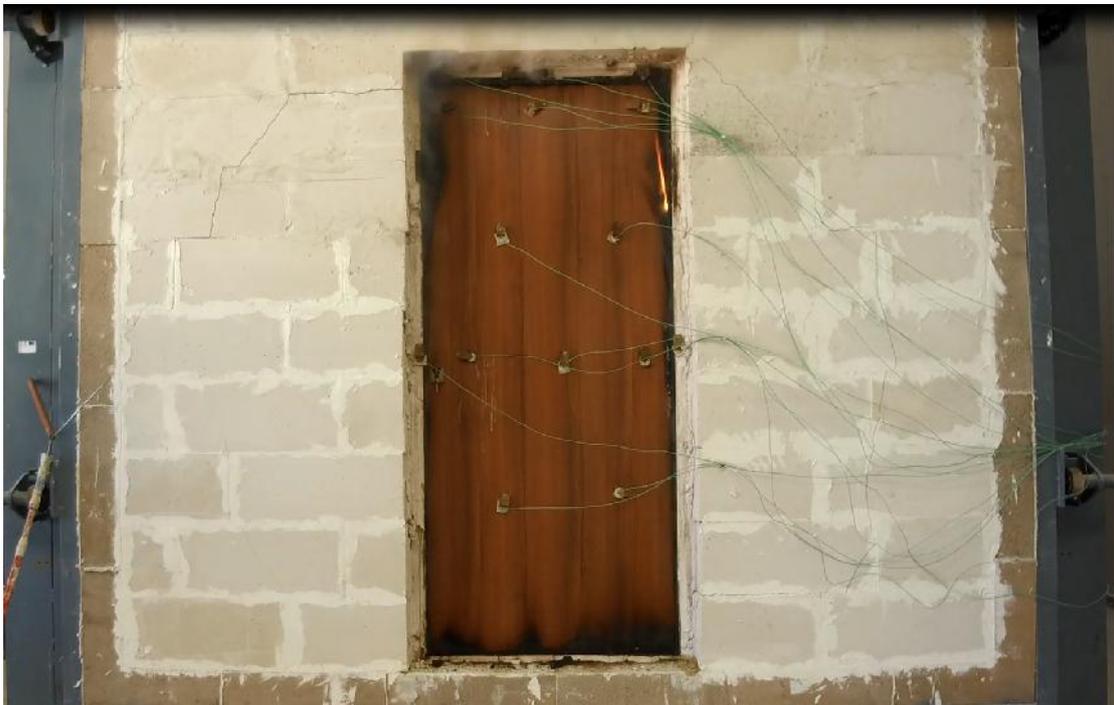
**Fig. 10 Sustained flaming (continuous flame lasting more than 10 s) at 1h 19 min post the commencement of the test**

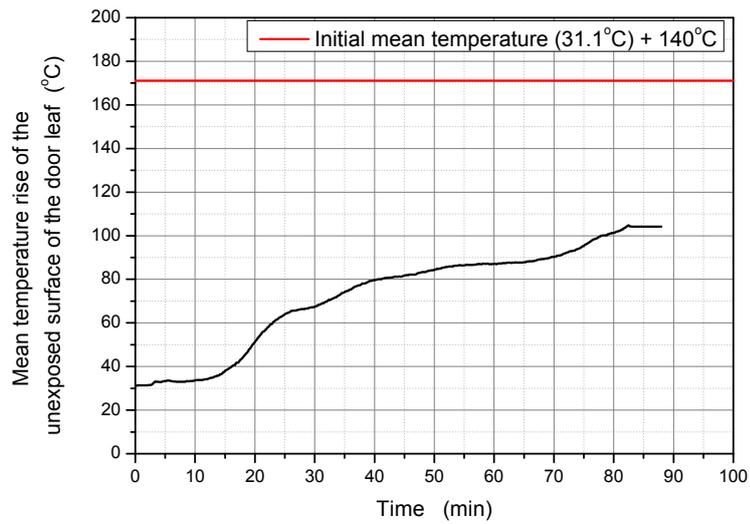
**Fig. 11 Mean temperature rise of the unexposed surface of the door leaf versus time [fire insulation: assessment of point (i)]**

The assessment of point (i) is shown in **Fig. 11**. The assessment of point (ii) – considering all door leaf thermocouples – is shown in **Fig. 12**. The assessment of point (iii) is shown in **Fig. 13** (all door frame thermocouples were placed mid-width). Based on **Figs. 11-13**, the fire insulation class of the fire door is that of I2.

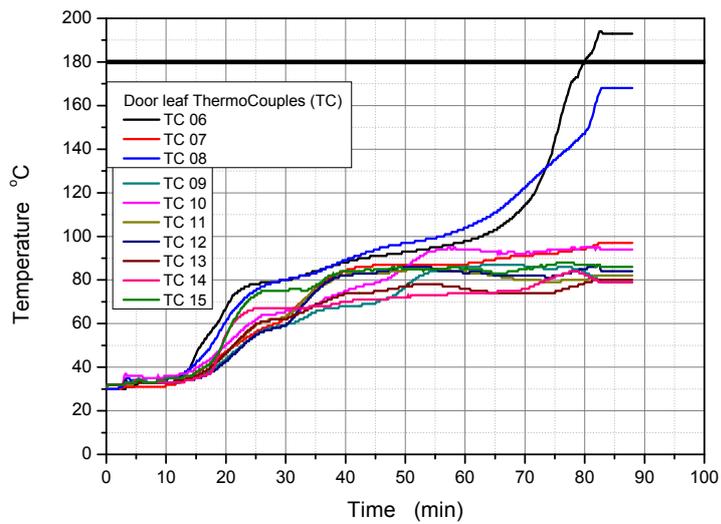
**Fig. 12 Temperature rise at any point of the unexposed door leaf surface versus time (all door leaf thermocouples considered) [fire insulation: assessment of point (ii)]**

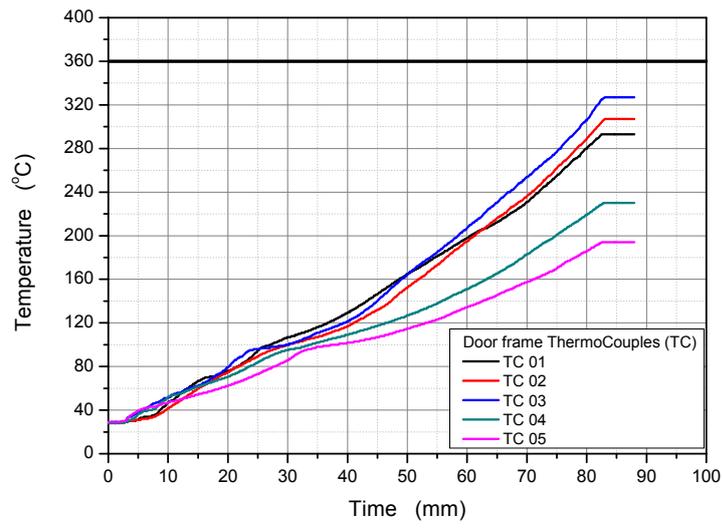
**Fig. 13 Temperature rise at any point of the door frame versus time [fire insulation: assessment of point (iii)]**
